XXXVIII IAH Congress

Groundwater Quality Sustainability
Krakow, 12–17 September 2010

abstract id: **477**

title: **Damming of water inflows in the western section of the
“Wieliczka” Salt Mine as an example of one of the methods
used for eliminating water hazards in salt mines**

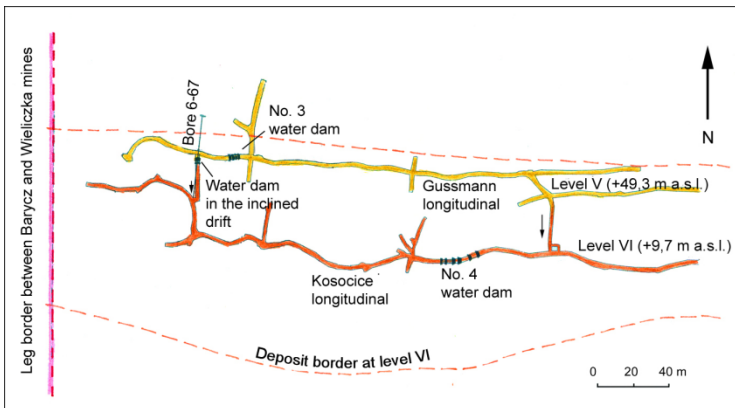
The flooding of the western border of the Wieliczka Salt Mine may serve as a good example to present, on the one hand, the mistakes in the art of mining which in effect lead to the penetration of water into the mine, and on the other hand, the existence of favourable geological and mining conditions for constructing water dams. In this part of the mine, the deposit was cut with several corridor excavations (Fig. 1). In August 1959, while working in the western section of the mine, at the end of level VI, during the process of executing a horizontal test bore 6-67

towards the north, the water bearing layer was drilled causing water to penetrate into the salt mine at a max. volume flow of 58 m³/h.

Figure 1. Location of water dams no. 3 and 4 in the western section of the Wieliczka Salt Mine.

The outflow was closed off by means of water dams (Fig. 1):

- Loam and concrete dam (No. 4) built in the Kosocice longitudinal at level VI,
- Concrete dam built in the inclined drift between levels V and VI,
- Block-loam-concrete dam (no. 3) constructed in the Gussmann longitudinal at level V (Fig. 2).

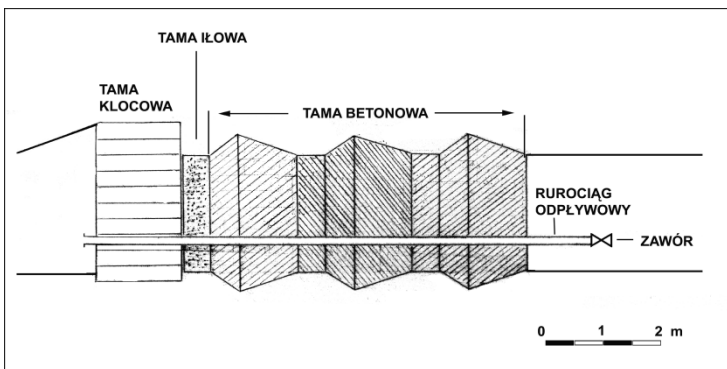
Figure 2. Structure section of the block-loam-concrete water dam in the Gussmann longitudinal (Level V).

Dam no. 3 was built due to the appearance of leaks in the dam located in the inclined drift and due to the insufficiency of the applied cementing processes.

Virtually, it was never possible to maintain the tightness of the dams for a longer period, and therefore, the dams have undergone cement tightening processes several times. A pipe system has been constructed at dam no. 3, level V, and dam no. 4, level VI, with fitted valves and ma-

nometers checking the pressures of the brine behind the dams (Sękiewicz, Markowski 1963). The pressure, until December 1961, at dam no. 3 was maintained between 0.20–0.25 MPa; at dam no. 4 between 0.63–0.85 MPa. Then, the pressure began to rise between reaching max. value 2.18 MPa (dam no. 3) and 2.65 MPa (dam no. 4), and then gradually began to drop coming at present to 0.42 MPa (dam no. 3) and 0.81 MPa (dam no. 4) (Water dam control book, 1965–2009).

The water dam complex at levels V and VI, in the western section of the mine, can be considered as efficiently closed off from inflows to the mine if not for the problem of the control pipeline system which is susceptible to corrosion. At present, the best solution seems to be the tight liquidation of the system connected with the liquidation of the Kosocice and Gussmann longitudinal sections, while the pressure behind the dams can be checked at the surface by means of a piezometric bore.
