When is a rock engineering design acceptable

2.1 Introduction

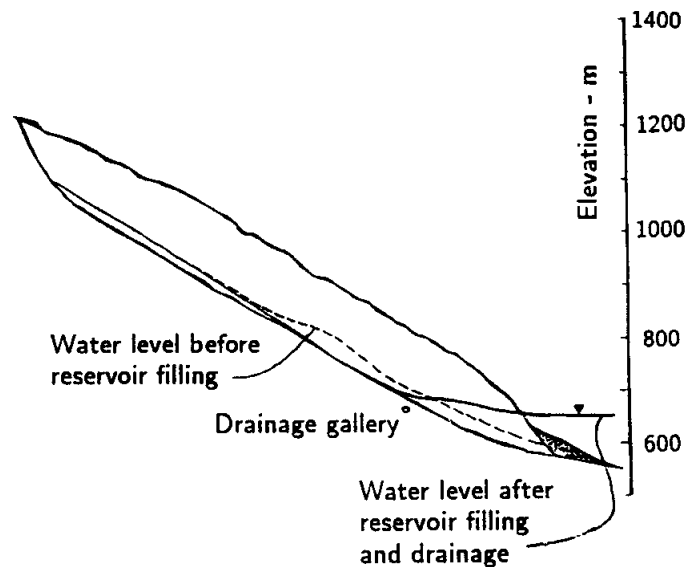
Figure 2.1 : Section through Dutchman's Ridge showing potential slide surface and water levels before and after drainage.

A section through Dutchman's Ridge is given in Figure 2.1 and this shows the water levels in the slope before reservoir filling and after reservoir filling and the construction of the drainage system. Figure 2.2 shows contours of reduction in water levels as a result of the installation of the drainage system which consisted of 872 m of adit and 12,000 m of drainhole drilling. Note that the drawdown area on the right hand side of the potential slide was achieved by long boreholes from the end of the drainage adit branch.

Comparative studies of the stability of the slope section shown in Figure 2.1, based upon a factor of safety of 1.00 for the slope after reservoir filling but before implementation of the drainage system, gave a factor of safety of 1.06 for the drained slope. This 6% improvement in factor of safety may not seem very significant to the designer of small scale rock and soil slopes but it was considered acceptable in this case for a number of reasons:

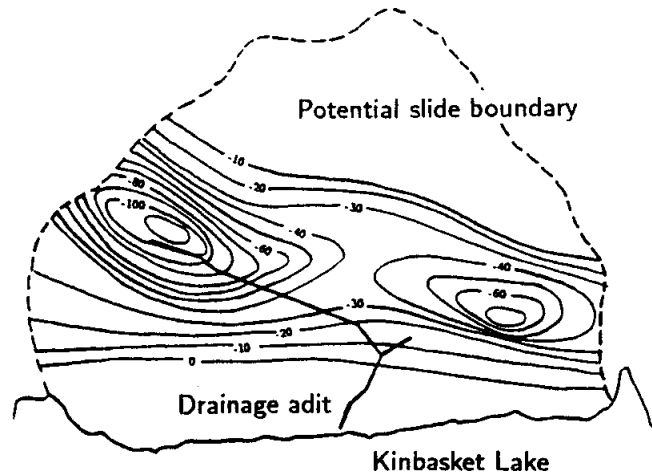
Figure 2.2 : Contours of water level reduction (in metres) as a result of the implementation of drainage in Dutchman's Ridge.

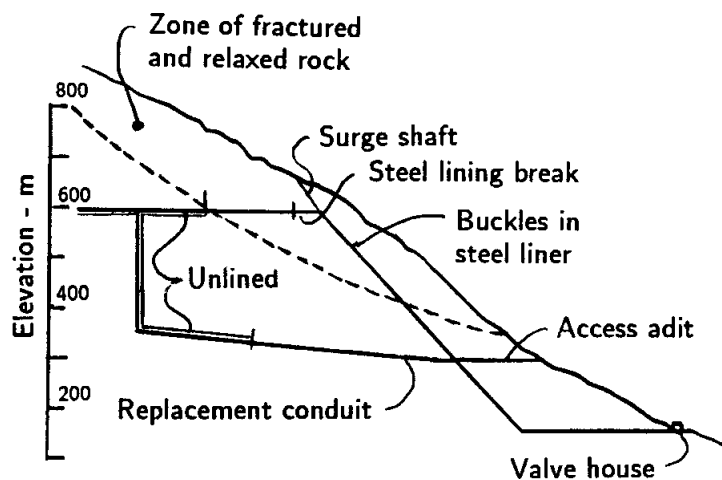
Figure 2.3 is a section through part of the power tunnel for the Wahleach hydroelectric project in British Columbia, Canada. A break in the steel lining in this power tunnel occurred in January 1989 and it is thought this break was caused by a slow down-slope gravitational movement caused by block rotations within a near-surface zone of loosened jointed rock.

Figure 2.3 : Cross-section through a section of the Wahleach power tunnel showing the original tunnel alignment and the location of the replacement conduit. The dashed line is the approximate location of a gradational boundary between loosened, fractured and weathered rock and more intact rock. Down-slope movement currently being monitored is well above this boundary.

The water conduit operated without incident between the initial filling in 1952 and May 1981 when leakage was first noted from the upper access adit located near the intersection of the inclined shaft and the upper tunnel (see Figure 2.3). This leakage stopped when two drain pipes embedded in the concrete backfill beneath the steel lining were plugged at their upstream ends. Large holes had been eroded in these drainage pipes where they were not encased in concrete and it was concluded that this corrosion was responsible for the leakage. This conclusion appeared to be valid until 25 January, 1989 when a much larger water flow occurred.

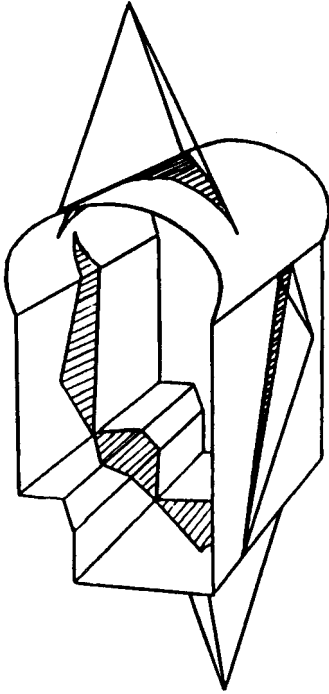
Figure 2.4 : Perspective view of Río Grande power cavern showing potentially unstable wedges in the roof, sidewalls, bench and floor.

Figure 2.4 is a perspective view of the Río Grande power cavern showing typical wedges which can be formed in the roof, sidewalls, bench and floor by joint sets 2, 3 and 4. These figures represent the maximum possible sizes of wedges which can be formed and, during construction, the sizes of the wedges were scaled down in accordance with average joint trace lengths measured in the excavation faces. In Figure 2.4 it is evident that the roof and the two sidewall wedges were potentially unstable and that they needed to be stabilised. This stabilisation was achieved by the placement of tensioned and grouted rockbolts which were installed at each stage of the cavern excavation. Decisions on the number, length and capacity of the rockbolts were made by on-site geotechnical staff using limit equilibrium calculations based upon the volume of the wedges defined by the measured trace lengths. For those wedges which involved sliding on one plane or along the line of intersection of two planes, rockbolts were installed across these planes to bring the sliding factor of safety of the wedge up to 1.5. For wedges which were free to fall from the roof, a factor of safety of 2 was used. This factor was calculated as the ratio of the total capacity of the bolts to the weight of the wedge and was intended to account for uncertainties associated with the bolt installation.

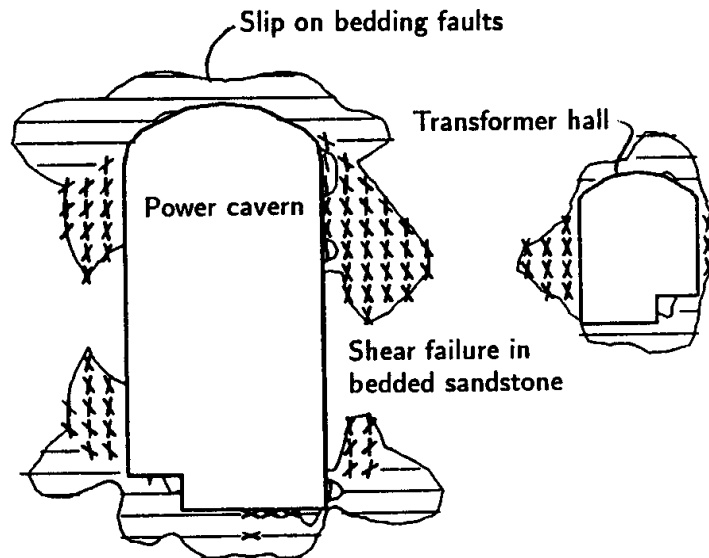
The results of a simple analysis of the zones of overstress in the rock mass surrounding the Mingtan underground excavations are presented in Figure 2.5. The crosses in this figure are directions along which shear failure is predicted in the bedded sandstone while the horizontal lines indicate slip along the faults (assuming $c = 0.15$ MPa, $\phi = 30^\circ$). While it is not claimed that this analysis adequately represents the complex process of failure initiation and propagation on the inclined faults and in the jointed rock mass surrounding the caverns, it does give sufficient information to suggest that the cavern can be stabilised by means of a pattern of long grouted cables supplemented by a layer of shotcrete on the excavation surface.

Figure 2.5 : Predicted zones of over-stress along faults and in bedded sandstone surrounding the power cavern and transformer hall of the Mingtan Project.

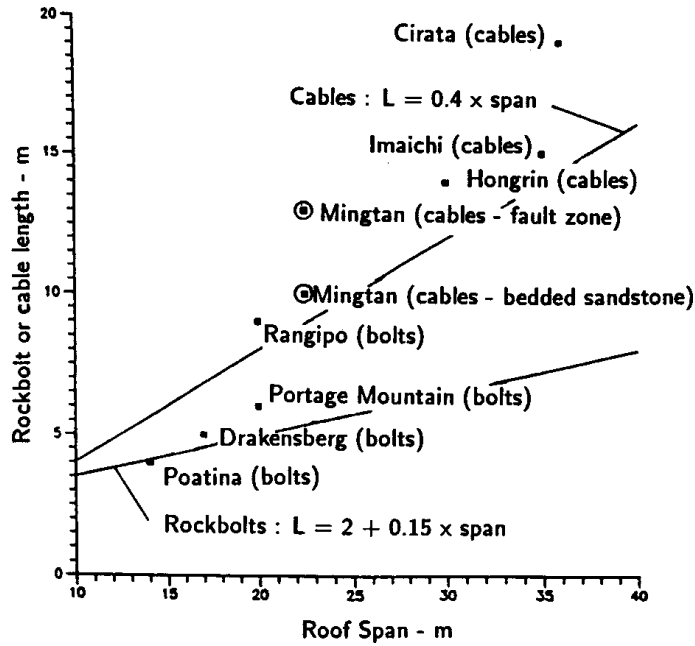
The design of the reinforcing cables was based upon experience and precedent practice. Figures 2.6 and 2.7 give the lengths of rockbolts and cables in the roof and sidewalls of some typical large powerhouse caverns in weak rock masses. Plotted on the same graphs are empirical relationships suggested by Barton (1989) for bolt and cable lengths for underground powerhouses.

Figure 2.6 : Lengths of rockbolts and cables used for roof support in some large caverns in weak rock. Equations defining trend lines were suggested by Barton (1989).

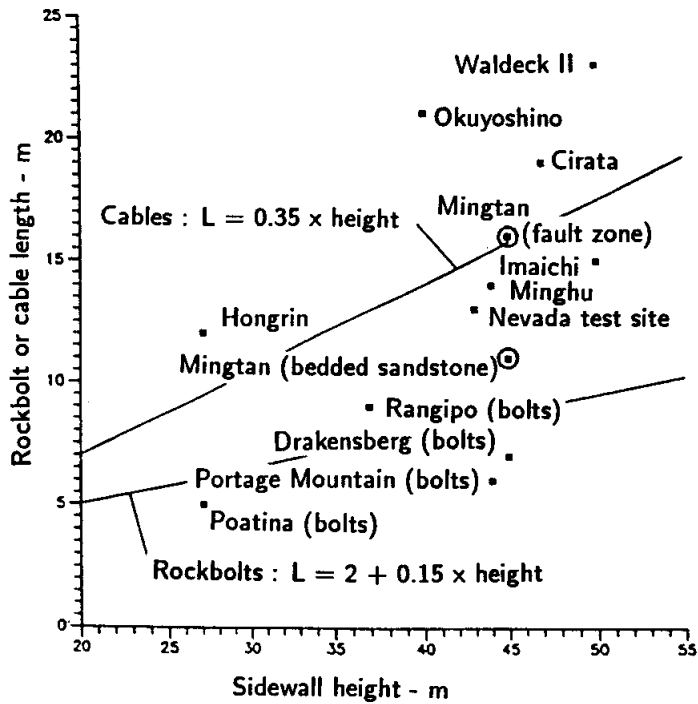
Figure 2.7 : Lengths of rockbolts and cables used for sidewall support in some large caverns in weak rock. Equations defining trend lines were suggested by Barton (1989).

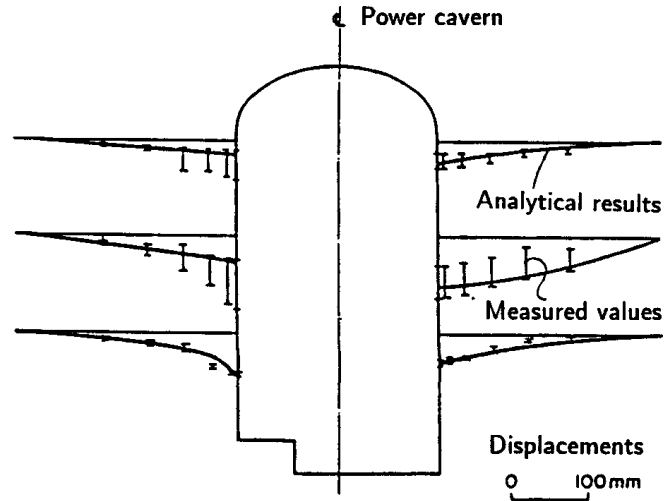
Figure 2.9: Comparison between calculated and measured displacements along six extensometers installed in the sidewalls of the Mingtan power cavern.

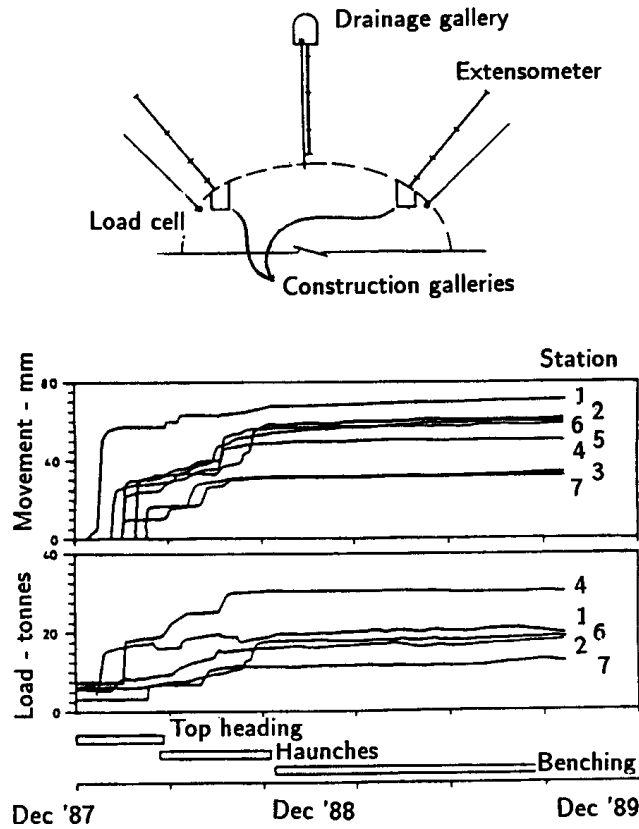
Figure 2.10 : Surface displacements and cable loads measured at seven stations along the power cavern axis.

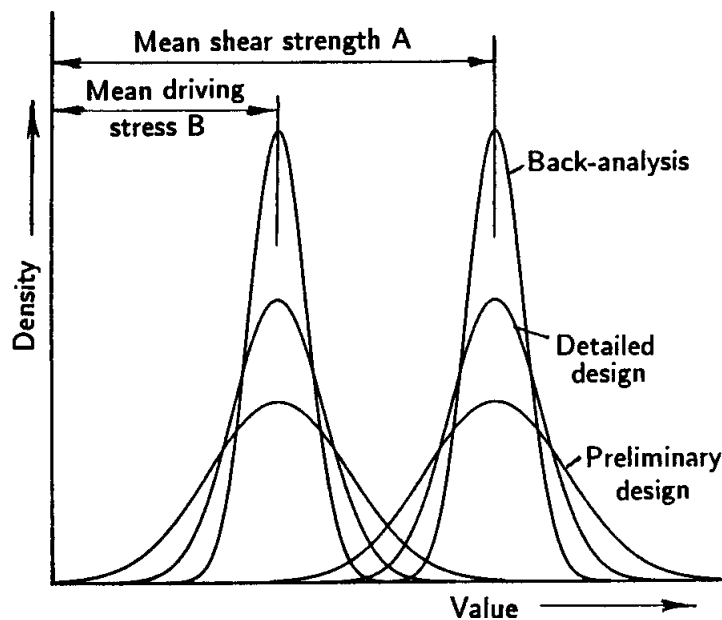
Figure 2.11 : Hypothetical distribution curves representing the degree of uncertainty associated with information on driving stresses and shear strengths at different stages in the design of a structure such as a dam foundation.

Figure 2.11 illustrates a set of hypothetical distribution curves representing the degree of uncertainty associated with available information on shear strength parameters and disturbing stresses for different stages in the design of a rock or soil structure. The factor of safety is defined as A/B where A is the mean of the distribution of shear strength values and B is the mean of the distribution of driving stresses. For the purpose of this discussion, the same factor of safety has been assumed for all three cases illustrated.

Figure 2.11 illustrates the hypothetical distribution curves for the range of values for shear strength and driving stresses for the case of a structure in which an existing failure has been carefully back-analyzed. Depending upon the degree of care which has been taken with this back-analysis, these curves will be very tightly constrained and a low factor of safety can be used for the design of the remedial works.
